Hammer Service Log

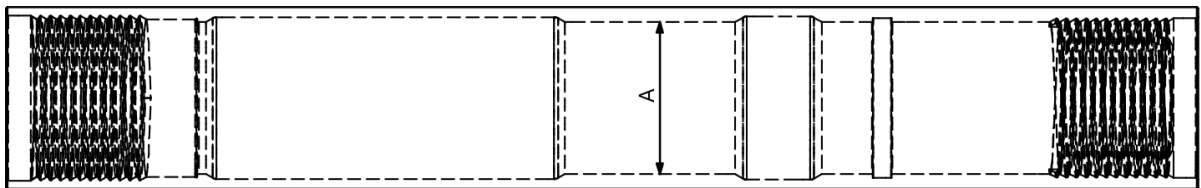
**WEAR SLEEVE / PISTON CLEARANCE**

Part	New Dimension		Discard Clearance
Wear Sleeve	A	4.74" (120.4mm)	≥0.010" (0.25mm)
Piston O.D	B	4.735" (120.29mm)

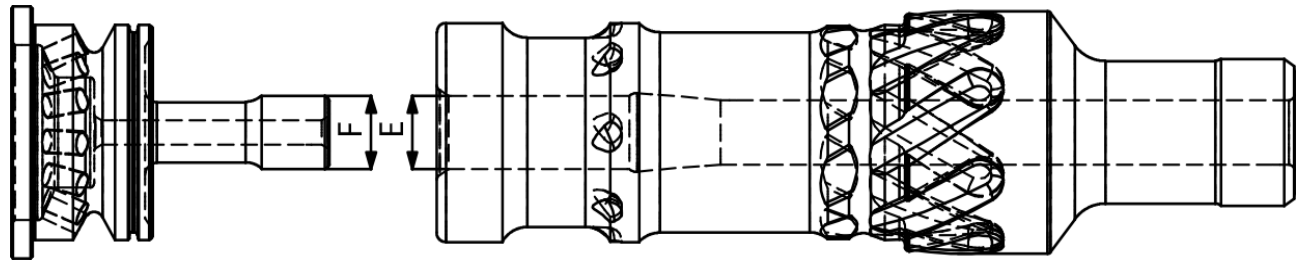
**DISTRIBUTOR PROBE / PISTON ID CLEARANCE**

Distributor Probe O.D	F	1.427" (36.25mm)	≥0.010" (0.25mm)
Piston I.D	E	1.437" (36.5mm)

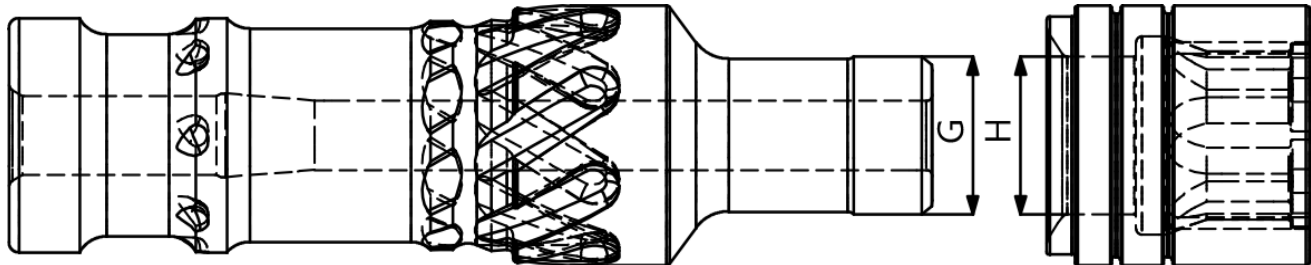
**Bearing / PISTON OD CLEARANCE**

Bearing I.D	H	2.878" (73.1mm)	≥0.010" (0.25mm)
Piston O.D	G	2.868" (72.85mm)
